# Hot Dip Galvanized Case Study No.24 Richards Bay Pontoon

Berth 208, a new bulk liquid berth, in the Port of Richards Bay. This berth shares the border with the eChwebeni Natural Heritage site, which is of conservation significance, consisting of an ecologically sensitive mangrove area.

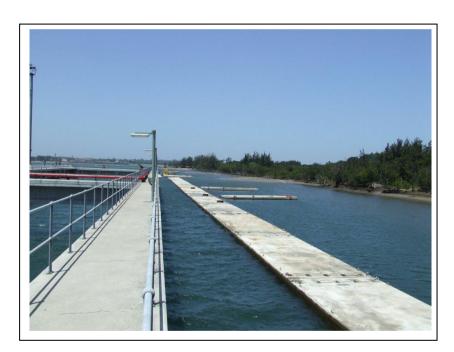
Completed pontoons in operation

Expected service life well in excess of 35 years with hot dip galvanized reinforcement within a severe marine environment

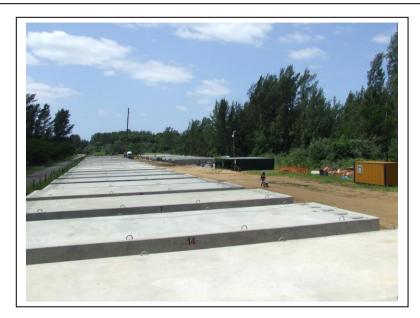
Completed Concrete Pontoons waiting installation

A total number of 44 concrete pontoons with galvanised reinforcing, each weighing approximately 63 tons and being 15m long x 5m wide and 1.5m deep were precast and lifted into the water and moored into position.

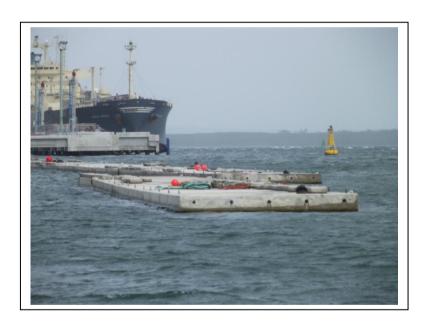
Hot dip galvanized reinforcement in cast concrete pontoons being floated out in preparation for positioning and anchoring to the sea bed

The pontoons are coupled together with specialised connectors and then moored to the seabed. The pontoons will extend over a distance of approximately 700m from the existing walkway of Berth 208 to Spinach point. They act as a floating wave attenuating structure to protect the environmentally sensitive mangrove area from further erosion and sand deposition blocking the drainage channel into the mangrove swamp area.
