Hot Dip Galvanized Case Study No. 10 Marian Island Weather and Research base

The Application

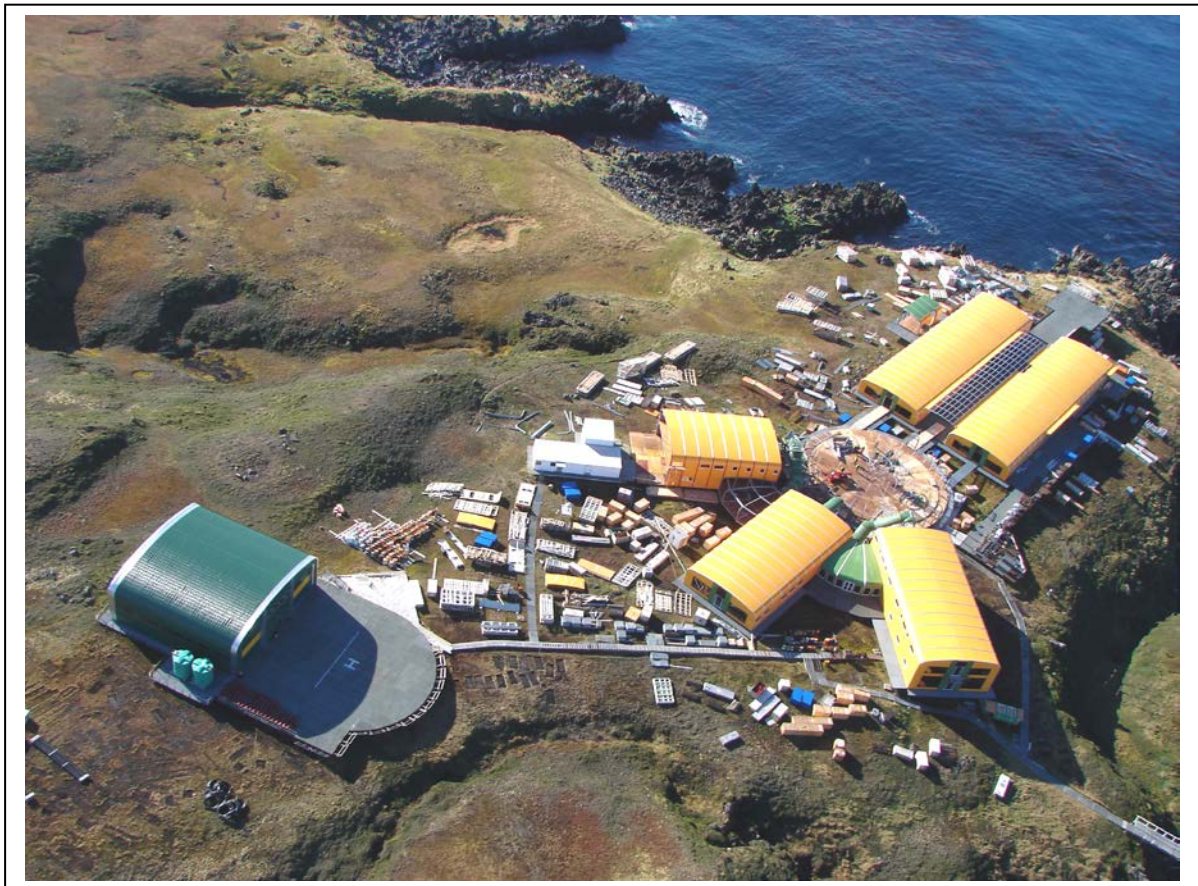
An aerial view of the base under construction
