Hot Dip Galvanized Case Study No. 23 Rural Pedestrian Bridges

The Application

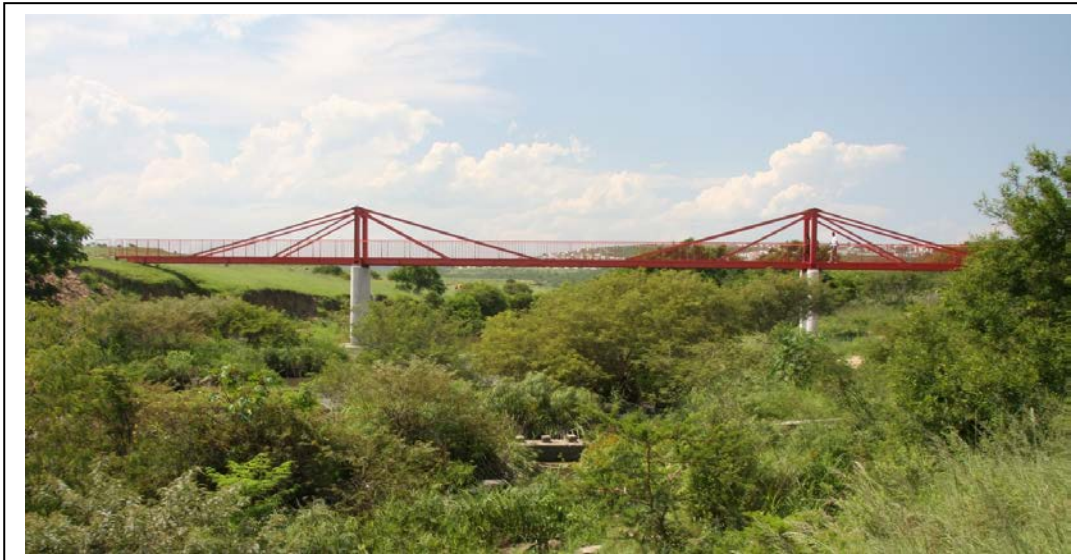
**Zwelitsha Pedestrian Bridge over the Buffalo River
Eastern Cape
Hot Dip Galvanized and painted**

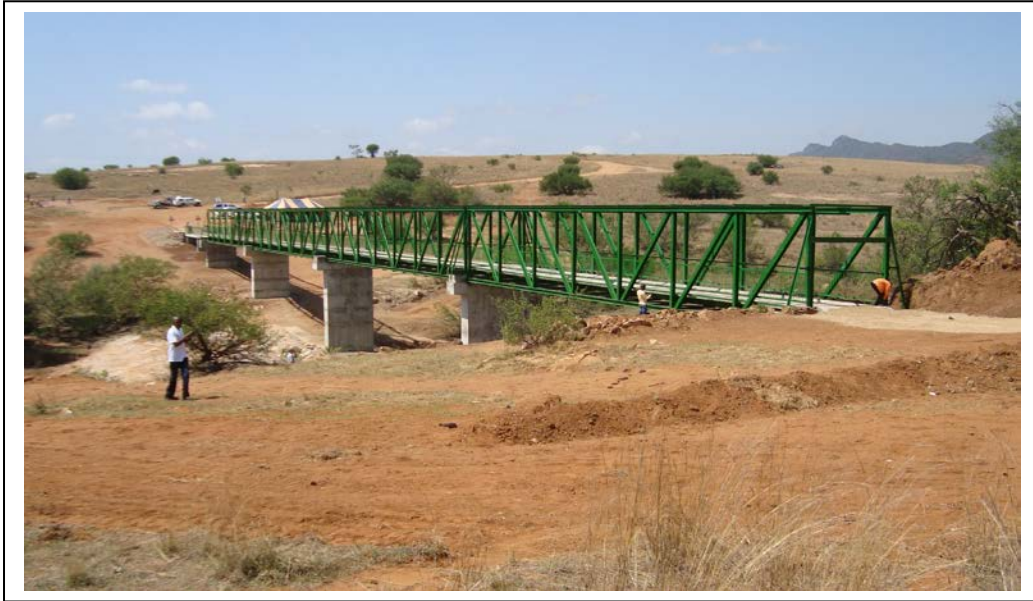
**Ntombe River Bridge
Hot Dip Galvanized and painted
Northern Kwazulu Natal – near the site of the
Battle of Ntombe drift 1879**

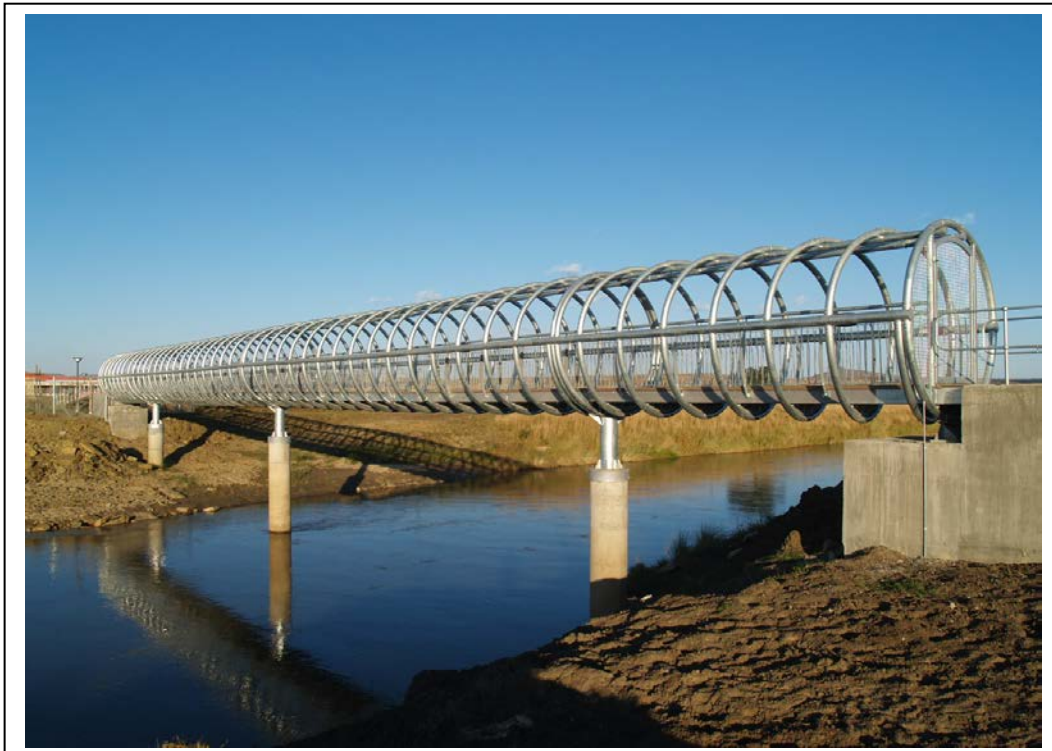
**Ncome Museum Pedestrian Spiral Bridge
Kwazulu Natal – the site of the Battle of Blood River
16 December 1838**
